# 3-STEP BELZONA CAVITATION SOLUTION FOR KAPLAN TURBINE BLADES

ID: 6087

Hydroelectric Plant, Northern Italy

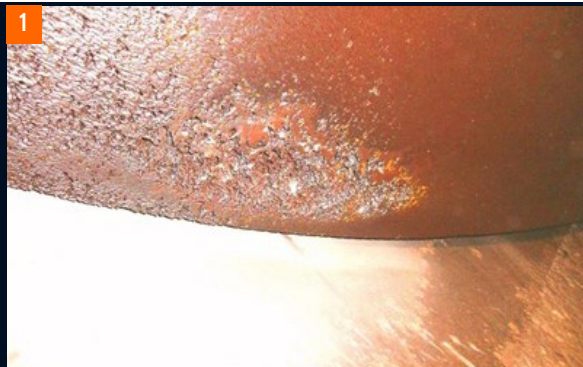
Four blades of the Kaplan turbine were experiencing metal loss as a result of cavitation. In some areas, through-wall defects started to appear. The customer previously attempted to repair the damage by welding without success.

1. Cavitated turbine blades
2. Rebuilding with Belzona 1311
3. Belzona 1341 applied
4. Belzona 2141 applied onto the edges
