# BELZONA KEEPS THE FLOW GOING

ID: 6088

Pumps from cooling water system

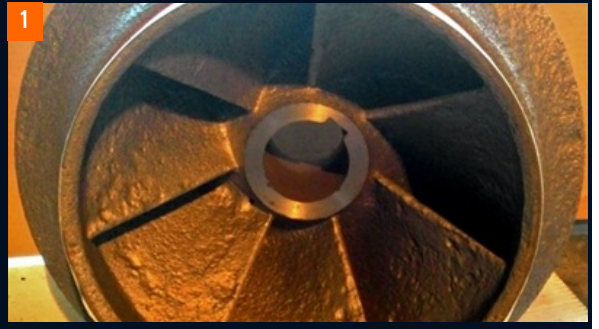
Impeller vanes on water pumps had been damaged by cavitation erosion corrosion, leading to reduced efficiency.

1. The damaged impeller
2. Surface profile being restored with Belzona 1111
3. Impellers finished with Belzona 1341

Application was carried out in accordance with Belzona Know-How System leaflet CEP-10. Original profiles were restored with Belzona 1111 before applying two coats of Belzona 1341 to provide future erosion corrosion protection to the impellers.
