# BELZONA REPAIRS CONCRETE ROAD IN CHEMICAL PLANT

ID: 6091

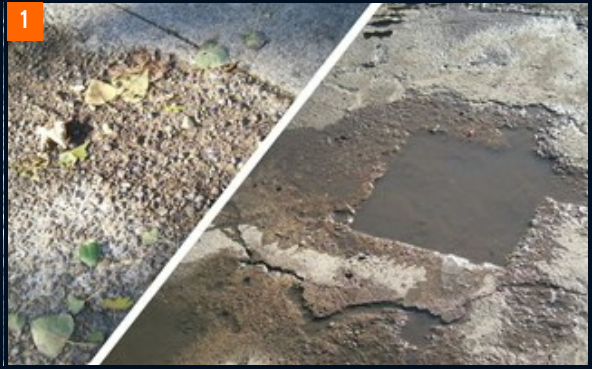
The roads on site had suffered attack from chemicals and regular heavy lorry traffic had cracked and eroded the concrete in many areas around the plant, including access roads. Repairs had been completed several times previously with cementitious materials. These had, however, never survived for long and once again the uneven surfaces had become hazardous for vehicles and foot traffic alike.

1. Typical damage on roads around site
2. Cracks filled and area resurfaced
3. Further repairs completed in main road
4. Repair revisited after 5 years

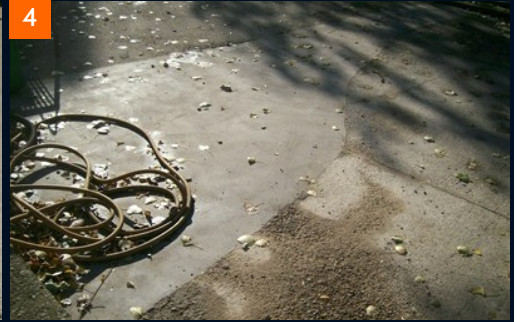
The Belzona solvent free concrete repairs offered a long lasting solution with a proven track record. Due to the extent of repairs required, Belzona 4131 was chosen as the most cost effective solution. For deep damage, Belzona 4131 was bulk filled 50/50 with 6mm pea gravel and resin before topping with Belzona 4131. The repairs were revisited after 5 years and there was only minor cracking in the heaviest traffic areas where it was known that there were still loose slabs.
