# WASTEWATER CLARIFIER REPAIRS COMPLETED QUICKLY WITH BELZONA

ID: 6093

Running track on two concrete clarifiers.

Water treatment plant, Tarbert, Scotland

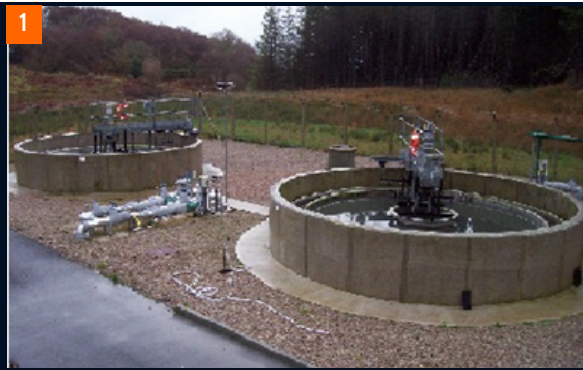
1. The two clarifiers before work started
2. Damage caused by the bridge wheel
3. Belzona 4131 applied to the top of the wall
4. Completed application

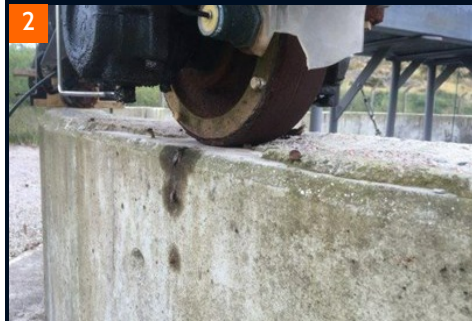
Running track on top of wall for distributor arm had been experiencing damage. The distributor wheels had caused impact & abrasion damage over time. Coupled with freeze/thaw, this had seriously damaged the substrate. Only a limited shutdown window was available for the repair.

Using Belzona 4131, a repair could be completed in a fraction of the time it would take to knock down the clarifier walls & rebuild them. Belzona 4131's chemical & impact resistance will also stop the original problem from re-occurring.
