# UNDERGROUND PIPE REPAIRED WITH BELZONA SUPERWRAP II

ID: 6094

Underground pipe had developed thin-wall defect

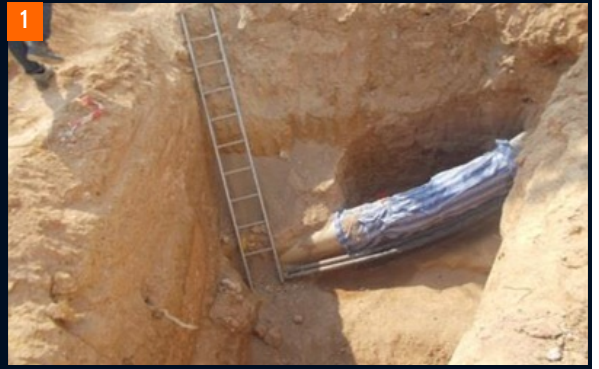
Internal local corrosion, detected by inspection pig, had created a thin-wall defect in the pipe, which had a design pressure rating of 100 bar(g).

1. The damaged pipe
2. Grit blasting the surface
3. First layer of Belzona 9381 and Belzona 1982 applied
4. Final layer of Belzona 1982 applied
