# BELZONA REFURBISHES SPLIT CASE PUMP

ID: 6095

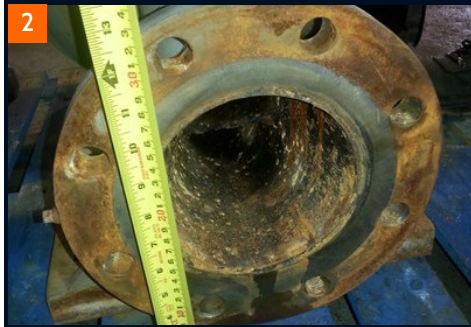
Pump had been experiencing erosion/corrosion. Damage had occurred to the existing coating & some of the underlying steel substrate had been eroded away. If another model of pump were to be installed in this instance the surrounding pipework would have to be modified.

1. Pump casing before
2. Damage before
3. Casing after application of Belzona 1341
4. Completed application

The application was carried out in accordance with Belzona Know-How System Leaflets CEP-1 and CEP-3. The damaged areas around the wear rings were rebuilt with Belzona 1111 before the casing was coated with two coats of Belzona 1341.
