# BELZONA RECESSED LINING MARKING SURVIVES CONSTANT ABUSE

ID: 6097

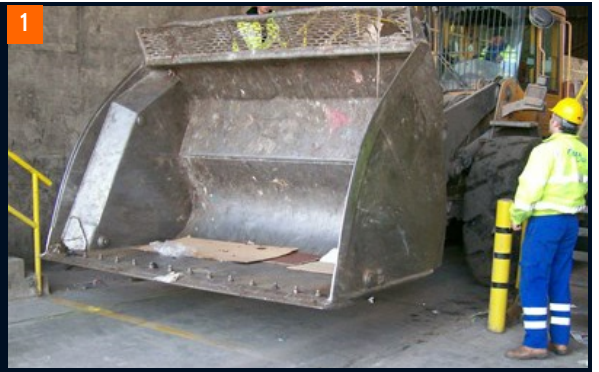
1. Heavy plant shovel operating on site
2. Trial area 1 year after application in 2009
3. Recessed application of Belzona 5231
4. Completed line marking on top deck in 2012

Application was carried out using a modified version of Belzona Know-How System Leaflet FPA-4. A channel was cut into the floor about 160mm wide and 5mm deep. A self-levelling screed was made using Belzona 5231 and Belzona 9221 mixed 3:1 which was poured into the channel.

In 2009 Belzona applied trial areas of Belzona 4411 on the surface and also a recessed application of Belzona 5231. After 3 years the surface application had largely been scraped away, whereas the recessed application was still in very good condition. The recessed solution was immediately taken up by the client and installed along the 37m of the top deck of this facility. Despite persistent abuse from the heavy plant shovels, it remains intact over 6 years later. Areas that only suffer foot traffic are still lined with Belzona 4411.
