# SUBTERRANEAN BELZONA SUPERWRAP II APPLICATION

ID: 6099

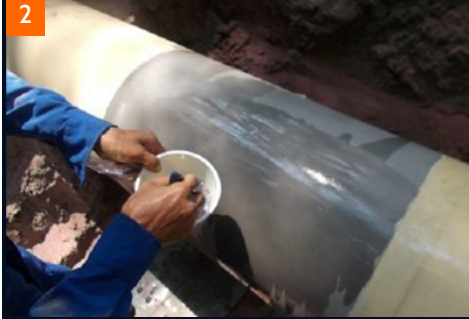
Inspection pigs had detected external local corrosion, which had created a thin-wall defect in the pipe.

1. Thin-wall defect
2. First layer of Belzona 1982 applied
3. Layer of 9381 and 1982 being applied
4. Completed application
