# BELZONA ICE MAKER DRUM

ID: 61

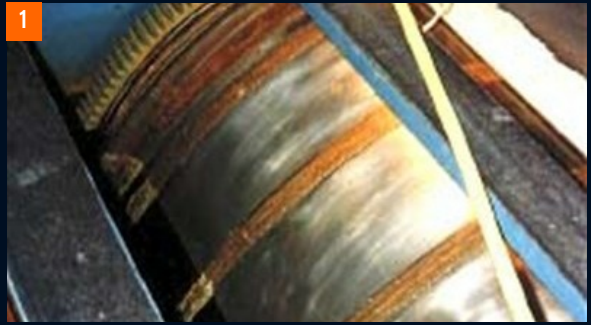
Over time rubber is worn. Ethylene glycol leaks from drum through worn joints and prevents freezing of water and production of ice.

1. Ice maker drum with worn rubber coated seals leaking glycol.
2. Duct tape used for a neat repair and Belzona 2221 applied.
3. The finished application; replacement cost saved.
