# BELZONA RESTORES VACUUM PUMP

ID: 6100

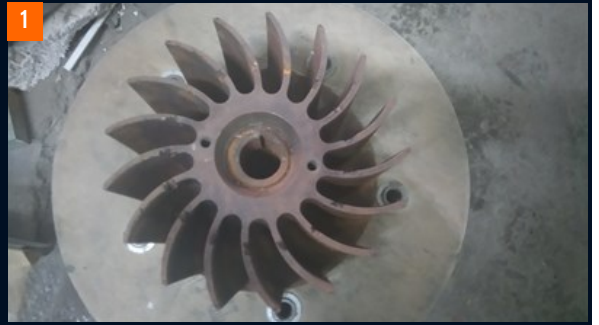
The vacuum pump rotor was exposed to aggressive corrosion and its efficient working life was very short. The client required a solution that improved the performance of the damaged pump and gave it new life.

1. Overall condition of rotor
2. View of the condition of the rotor
3. Impeller after grit blasting
4. Completed application
