# FLEXIBLE BELZONA BUND LINING

ID: 6102

Series of bunds in plant room for RO (Reverse Osmosis) water.

Hospital, Teesside, UK

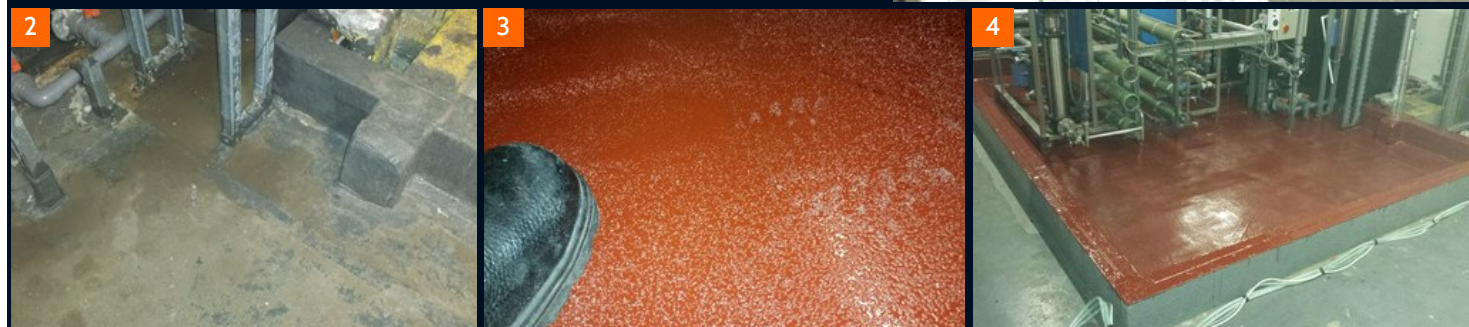
This RO Water Bund had been protected with flexible membrane sheets only 5 years previously. These thick sheets had been ineffective due to the footings and frames in this bund. Reverse Osmosis is a highly deionised form of water that is very reactive to concrete. The membrane had disbonded in several areas with one of the blisters being over 1m wide. The areas beneath this bund were highly sensitive rooms and so the client wanted to avoid disruptive preparation techniques such as grinding. Adhesion trials were performed to prove the adhesion of the Belzona system.

1. RO Water bund before work started
2. Existing membrane sheet close up
3. Grip incorporated in the top coat
4. Bund completed in Belzona 4361

Application was carried out in accordance with a modified version of Belzona Know-How System Leaflet TCC-15. Blistered membrane was cut away to a firm edge and Belzona 4131 was used to repair the concrete and relevel the areas. Following manual abrasion, the membrane was conditioned with Belzona 3921. Two coats of Belzona 4361 were applied with Belzona 9221 scattered in the topcoat to provide grip.
