# CAST IRON BELZONA GRIP ON COAST

ID: 6105

Ancient Cast Iron Steps leading down to the breakwater and beach.

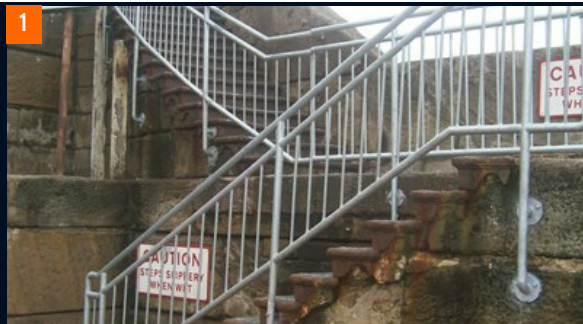
1. 25 steps to the breakwater and beach
2. Cast iron worn smooth
3. Same steps after application
4. Completed application

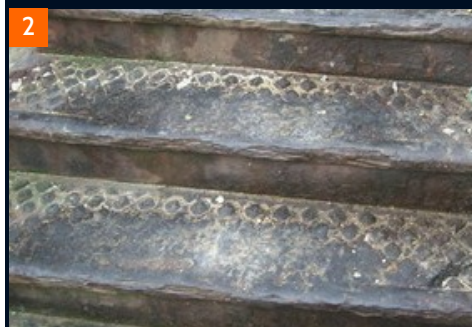
These steps had been worn down after decades of use from the public. The polished surfaces were slippery even when dry, and in wet conditions they were treacherous. These steps led to a very popular breakwater and beach, and so access through the day could not be restricted. In addition, there was about to be a major “Big Ships” event, and thousands of visitors were expected to be using these steps. With “Slips & Trips” being the main source of reported injuries in the UK, the client was very conscious of the risks to the public.
