# BELZONA REPAIRS AND PROTECTS CONCRETE FLOOR AND U-DRAINS FROM CHEMICAL ATTACK

ID: 6106

Floor and U-Drains Around Diaphragm Cells

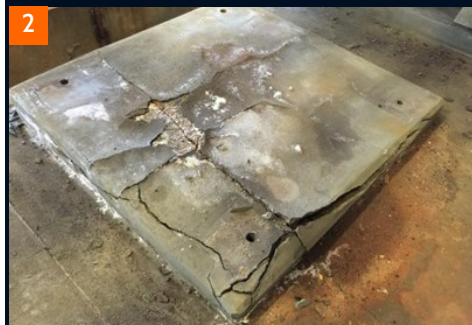
Chemical attack had caused damage to the concrete cell bases and multiple areas in the u-drains.

1. Damage on U-drains
2. Damaged diaphragm cell bases as a result of a chemical attack
3. Cell bases after the application
4. Completed application

The application was carried out in accordance with a modified version of Belzona Know-How System Leaflets FPA-1 for rebuilding worn and damaged floor surfaces and FPA-3 for protecting floors and drains against chemical attack. The concrete surface was prepared by removing loose and spalling concrete, pressure washing, abrasive blasting and diamond grinding. Belzona 4911 and 4131 were applied in accordance with Belzona's Instructions for Use. Two coats of Belzona 5892 at approximately 10 mils per coat were applied in accordance with Belzona's Instructions for Use. The entire application was completed per the details described in the Application Survey Report.
