# BELZONA GRIP SYSTEM KEEPS LORRIES MOVING

Checker Plate Weighbridge.

Chemical Plant, Cleveland, UK

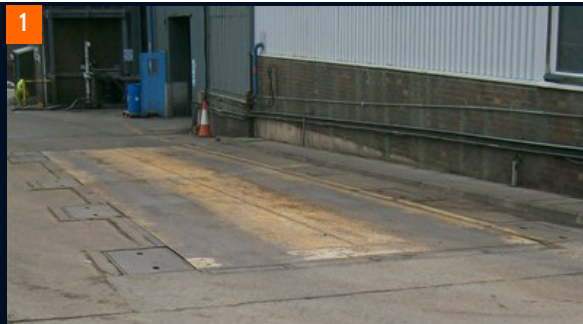
The client had an old weighbridge that had been constructed on a slope. Lorries were struggling to move off this as their tyres would just spin on the polished metal. They then had a new deck fabricated, but it was found that the problem persisted. Vehicles would have to reverse back towards the production area in order to gain enough momentum to get over the bridge. After a couple of “near misses”, a solution was urgently needed.

1. Original weighbridge in 2010
2. New weighbridge with application underway
3. Belzona 5811 being applied between grip areas
4. Completed application in 2011
