# BELZONA SEAMLESS ROOFING FOR SUBSTATIONS

ID: 6109

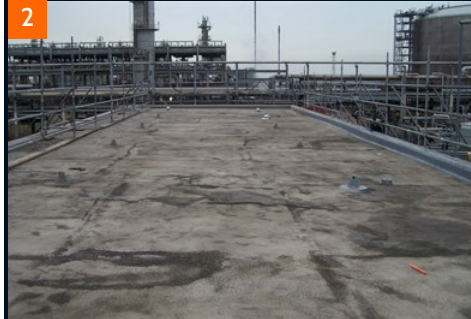
Flat asphalt roofs over plant electrical substations. The roof illustrated here was the first of many refurbished on site and comprised 18mm chippings over an asphalt deck totalling 260 square meters with extensive lichen and moss growth.

1. Substation flat roof
2. Asphalt de-chipped
3. New vent detail of finished system
4. Completed roof fully protected with Belzona 3131
