# BELZONA REBUILDS CAVITATED VANES

ID: 611

Five impellers of cooling pumps

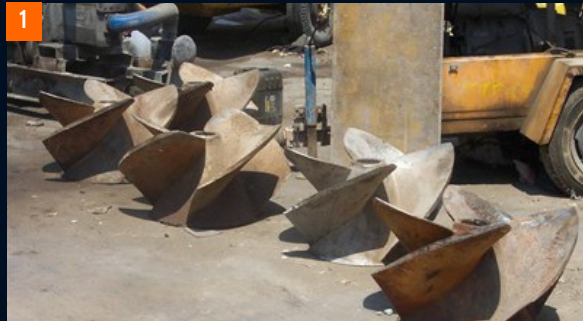
1. General view of the five impellers
2. The cavitated vanes
3. Rebuilding the vanes using Belzona 1311
4. Finished Impellers coated with Belzona 1321

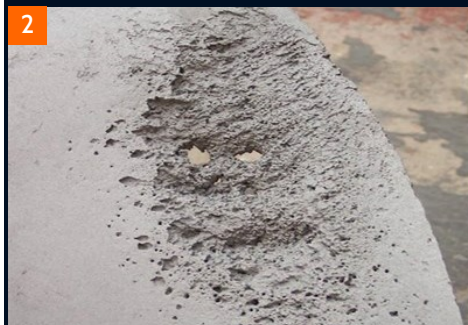
Severe cavitation caused holes, pittings and deformation in the profile of the vanes.

Belzona rebuilt the cavitation and pitting damage in the vanes restoring the correct profile using a simple technique, saving replacement costs and also providing more resistance to future cavitation.
