# BELZONA PROTECTS BOX GUTTERS

ID: 6111

Plastic Coated Box Gutters.

Corporate Office, Teesside, UK

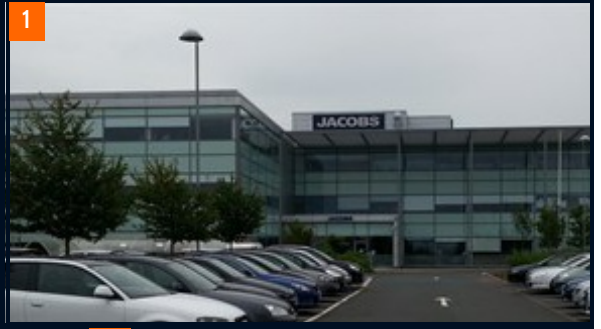
1. Building front aspect
2. Typical gutter on initial inspection
3. Application of Belzona 3111 underway
4. Application completed

With so many people already working in the building, the water based Belzona 3111 system was ideal. A seamless flexible membrane was applied along the full length of all of the roof gutters and up the joints of the parapet wall with a total length over 320 metres. Once completed, the contractor issued a warranty so that the client finally had the confidence to take ownership of the building.

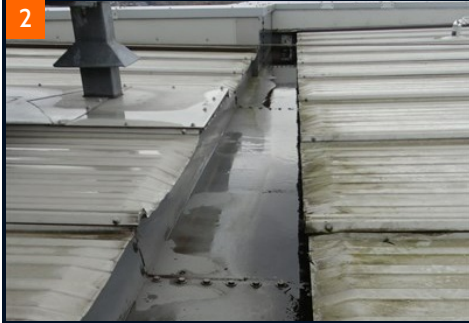
The client was about to take possession of a newly constructed office block. However, the gutters were leaking at multiple points around the building and so they were refusing to take ownership until the roof was watertight. It was thought that the joints and drain points were at fault. The main contractor had tried to seal these with a bituminous coating, which was ineffective and so needed to be removed. Belzona were approached for a liquid applied solution that could be backed by a warranty.
