# BELZONA SEALS SWITCH ROOM ROOF PENETRATIONS

ID: 6112

Switch room roof vents.

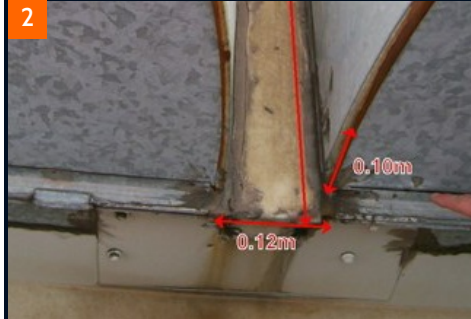
A series of vents and AC units had been positioned on roofs over the switch rooms. Cladding panels and sealant had been used in attempts to weatherproof the penetrations but this had proved ineffective. In addition, some of the fabrication joints for the vents were also failing, which allowed even more water in. After an incident which had forced sections of the power plant to shut down, Belzona were approached for a solution that could rapidly be installed to seal the complicated details and roof profiles.

1. Switch room vent, cladding detail
2. Failed fabrication seam
3. Seams and cladding sealed with Belzona 3111
4. Completed application
