# TEMPERATURE REDUCED ON METAL ROOF WITH BELZONA

ID: 6114

Steel roof over Medical equipment store.

Hospital, Teesside, UK

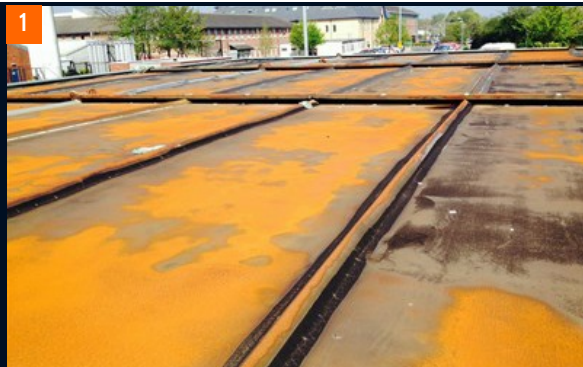
Leaks were evident from the jointing trims on the roof and the very narrow gutters. An additional problem during the summer months was the high internal temperatures of the rooms beneath and air-conditioning units would struggle to keep the areas cool enough for the staff and supplies. In fact, the building was known locally to staff as the “biscuit tin”, as you would bake inside it.

1. Corroded sectional metal roof
2. Gutter detail close up
3. Gutter detail coated with Belzona 3111
4. Completed application

The Belzona 3111 water based membrane was able to seal the most complex of geometries with a simple brush application. Despite the gutters being only 70mm wide and having restricted access, they were all successfully sealed. The whole roof was protected with Belzona 3111 in a light grey colour to help with solar reflection in the summer, and so help reduce the temperatures inside.
