# BELZONA REBUILDS THE WALLS OF A SECONDARY CONTAINMENT AREA

ID: 6115

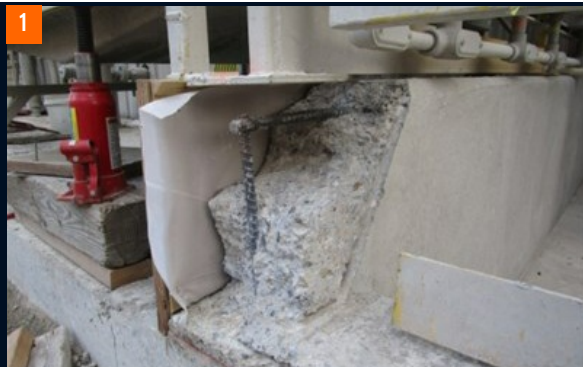
Severe cracks and damage in the walls of the ammonia secondary containment due to design issues.

1. Showing damage to the walls
2. Forming boards used for the application of Belzona 4154
3. Pouring of Belzona 4154
4. Completed application showing Belzona 4111 as a top layer

The damage at the SE corner required cutting out a section of the walls in one area and a simple removal of a small section at the SW corner. A grinder was used to remove oxidation from rebar. Belzona 4911 was applied to the steel rebar and concrete. Form boards were attached to the concrete to create a frame before pouring Belzona 4154. Once cured, the form boards were removed. A grinder was used to remove the gloss off of Belzona 4154, then the surface was wetted with Belzona 4911 to prepare it for the application of Belzona 4111 as a finishing layer.
