# BELZONA REJUVINATES AGED ASPHALT ROOF

ID: 6117

Asphalt roof over plant room.

Power Station, Teesside, UK

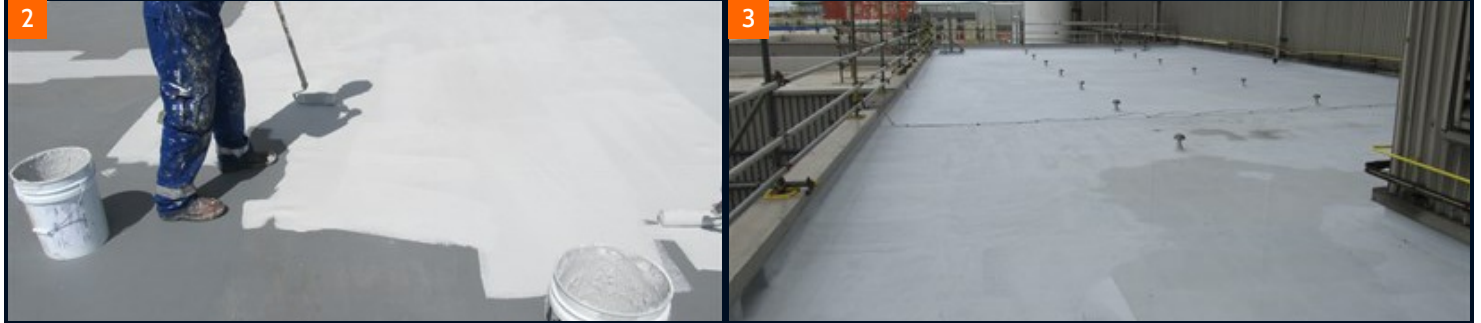
## PHOTOS

This aged asphalt roof was cracked in many places and there were several large ponding areas where water would not fall to drains. A much larger pitched roof above it also drained directly onto the asphalt, resulting the roof having to accommodate about six times more water than it was designed for. These problems had led to several leaks being identified in the plant rooms beneath and essential equipment was at risk of being ruined. Environmental and safety considerations mean the client preferred a water based system.

1. Roof with ponding areas on right
2. Application of Belzona 3111 underway
3. Protection completed

The application was carried out in accordance with Belzona Know-How System Leaflets RPA-6 and RPA-8.

The Belzona 3111 is a water based flexible material and has a BBA certificate with an assumed working life of 25 years. In addition, the materials are all cold applied, which was ideal for this site where all hot works are generally prohibited. As the membrane is lightweight, it can be applied directly onto the existing substrates, with no need to remove and renew the asphalt, which in turn greatly reduced the contract costs. The client was delighted with the results and work on further roofs around the site continues.
