# CHEMICAL BUILDING ROOF LEAK REPAIRED BY BELZONA 3111

ID: 6118

Chemical plant Roof

Chemical Company, Thailand

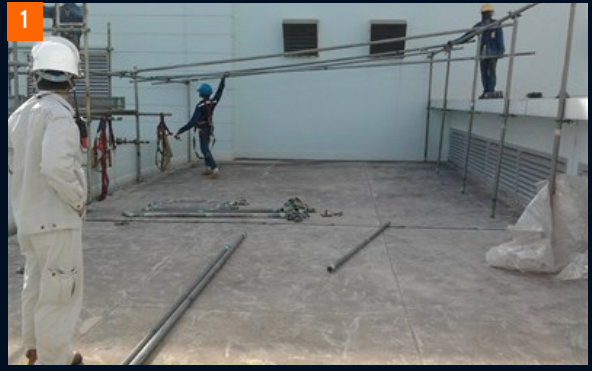
Leaks at roof joints allowed water to leak through causing damage to the chemicals stored below.

1. Overall picture of the area that need to be repaired
2. Belzona 3111 was applied
3. First coat of Belzona 3111 incorporating Belzona 9311 Reinforcement sheet being applied
4. Ongoing application of Belzona 3111 system to all roof joints

Application was carried out in accordance with Belzona Know How System Leaflet RPA-1 and RPA-2. The fully reinforced Belzona 3111 System was applied to bridge all joints on the roof.
