# STEEL PLATE BONDING WITH BELZONA 1511 FOR BRIDGE

ID: 6119

Steel deck of Rama IX Bridge was cracked.

Rama IX Bridge, Bangkok, Thailand

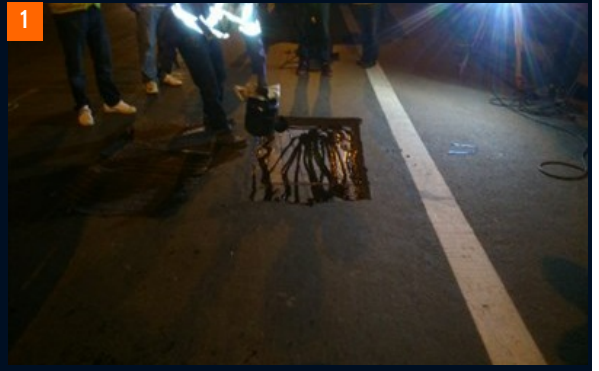
1. Belzona 1511 was applied on the repair area and on the prepared area of steel plate.

Drill a hole on the steel plate and tap in the screw to tighten the hook screw. The repair area was prepared with grit blasting and remove oil, grease, and contamination with MEK. And then, mix Belzona 1511 and apply it on the repair area and on the prepared area of steel plate, place plate on the repair area and leave cure. After that cut the hook screw and fill the asphalt to achieve the existing level.

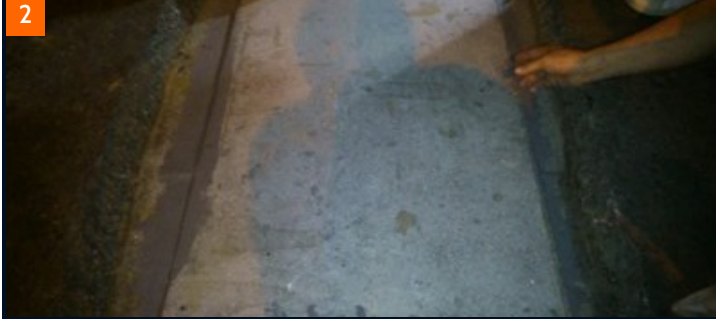
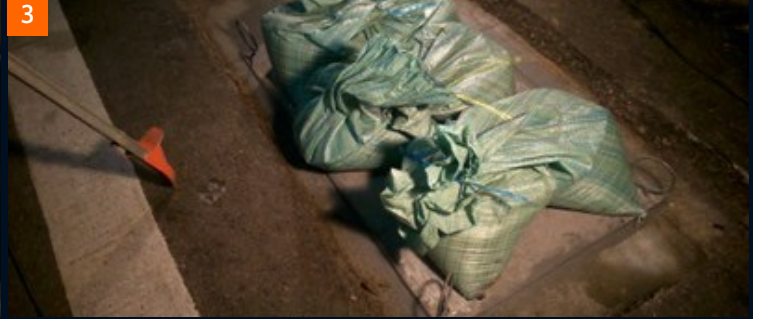
2 and 3 Place the steel plate on the repair area.
