# BELZONA PROTECTED SUBMERSIBLE SLUDGE PUMP SIX YEARS ON

ID: 6125

Casing and components of a submersible sludge pump.

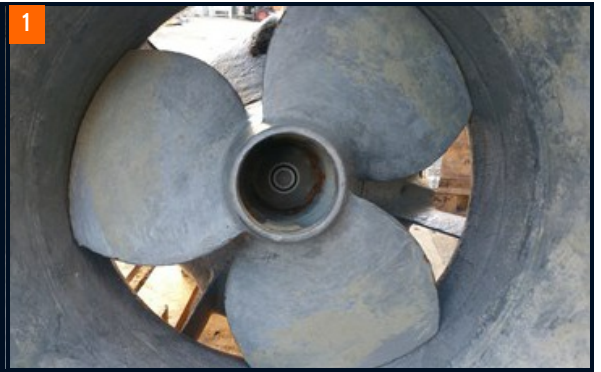
Previously the pump only lasted two years in service before requiring major overhaul. Originally coated in 2010 with Belzona, after six years of uninterrupted service, the customer opened the pump for mechanical maintenance. Belzona coating was found to be in excellent condition but it was decided to refresh the Belzona protection to prepare the pump for more years of service in sludge.

1. Internals after six years in service
2. Casing after six years in service
3. Impeller recoated in 2016
4. Casing and internals recoated in 2016

The application was carried out in accordance with Belzona Know-How System Leaflets CEP-1, CEP-3 and CEP-4. The coating applied in 2010 was roughened and the new coating was applied on top.
