# REFINERY SLOP TANK PROTECTED WITH BELZONA

ID: 6126

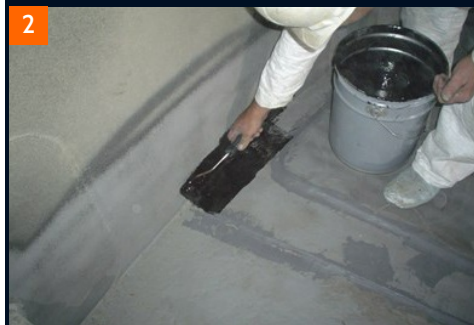
1. Picture of the tank
2. Filling the pits and welds with Belzona 1121
3. First coat of Belzona 5811, black
4. Final coat of Belzona 5811, beige

New steel plates were welded over the existing through wall defects. The welds and pits were filled with Belzona 1121. Two coats of Belzona 5811 were applied afterwards in two contrasting colors.
