# OFFICE BALCONY ROOF REPAIRED WITH BELZONA

ID: 6133

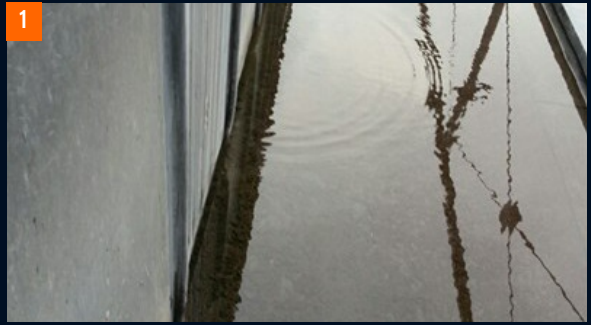
There were different substrates used for the roof & flashing, including felt and lead. There were also handrails & bolts to be removed that left gaps that had to be waterproofed. In particular, the balconies had developed ponding water, which, due to being north facing rarely dried up.

1. Ponding water on the roof 2. Balcony sections before coating 3. Roof area after coating 4 Balcony sections after coating

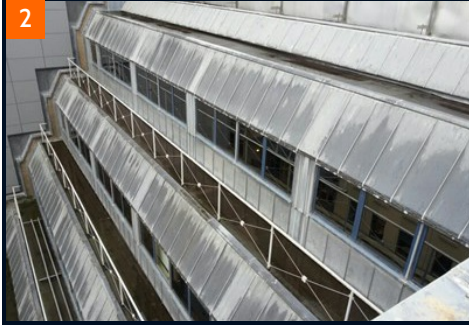
A set of roof balconies had developed leaks, particularly around joints, seams and flashings.
