# BELZONA SUPERWRAP II SOLUTION FOR CRUDE OIL PIPELINE

ID: 6134

Crude oil Pipeline at the refinery.

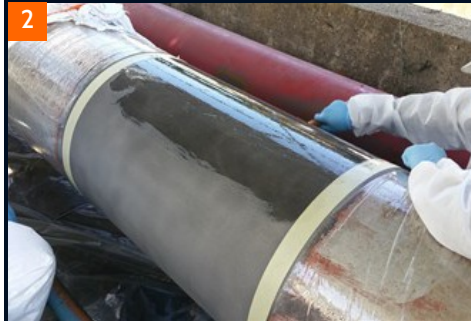
Pipeline had suffered thin-wall defects in eight separate areas.

1. Thin-wall defect on pipeline
2. Wetting out the surface
3. Belzona SuperWrap II applied
4. Repaired area overcoated with Belzona 5811
