# BELZONA BULKFILL RESTORES STEPS AT A HOSPITAL

ID: 6135

Four sets of stone steps at a hospital in Ontario Canada with large volume damage require cost effective and time critical repair.

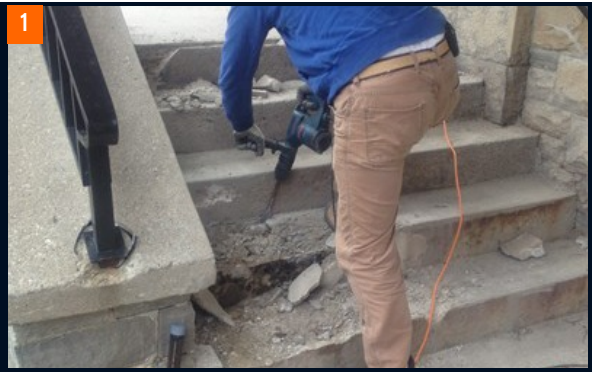
The steps had suffered severe damage and spalling caused by weathering, salt and freeze thaw effect. Large cracks and spalled stone were visible making the usage of the steps dangerous.

1. Preparing the stone back to firm substrate
2. Belzona 4154 being packed into former
3. Application of Belzona 4131
4. Finished application with Belzona 5231 and 4411

The damaged stone was removed back to a firm substrate. Due to the extent of the damage forms were created and Belzona 4154 was mixed with locally sourced aggregate and packed into place. Once cured the forms were removed and 1/4" of Belzona 4131 was applied over the stair treads and risers. To protect from further weathering and salt Belzona 5231 was applied over the steps with a high visibility yellow Belzona 4411 stripe at the edge of the step tread.
