# BELZONA REBUILDS AND PROTECTS VANES

ID: 614

Two water pump impellers

Water plant, Egypt

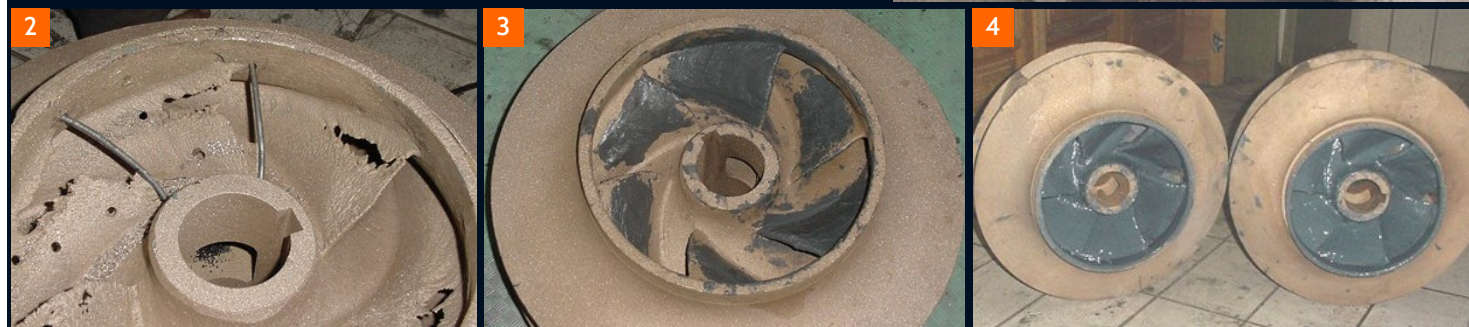
## PHOTOS

Vanes of the impellers were severely cavitated.

1. The cavitated vanes of the impeller
2. Preparing to rebuild the lost edges
3. Rebuilding the vanes
4. Vanes rebuilt and coated

Application was carried out in accordance with Belzona Know-How System Leaflet CEP-1 & CEP-3.

Belzona rebuilt the cavitated vanes saving replacement cost of the impellers. It also provided resistance to cavitation by coating the vanes with Belzona® 1321. This application was repeated with other impellers later and the impellers are still in service.
