# BELZONA BULKFILL REBUILDS HOSPITAL TRASH PAD

ID: 6140

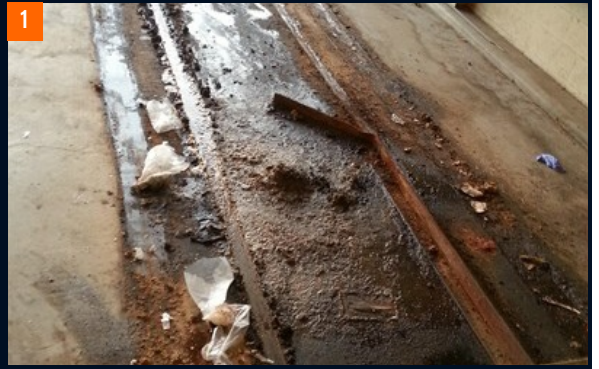
Concrete in roll-off area was deteriorating due to weight and dragging of trash containers. Large hole was a below ground conduit vault. Rain water was entering the vault area and causing electrical hazards.

1. Damaged concrete of the trash pad
2. Removing and scarification of the damaged concrete
3. Application of Belzona 4154 and 4131 as a top coat
4. Complete application
