# BELZONA PROTECTS NEW GLYCOL TANK

ID: 6146

A newly fabricated tank for an industrial refrigeration system was in need of corrosion protection.

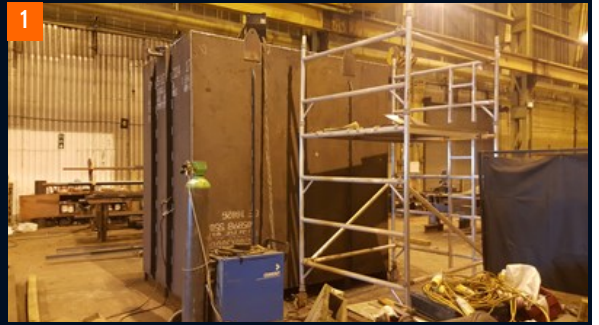
1. Newly fabricated tank
2. Tank onsite, laid on its side
3. Coating underway
4. Completed application
