# BELZONA SOLVES MISALIGNMENT ON QUARRY TRUCK SCALES

ID: 6147

Misalignment of metal approach plate to truck scales.

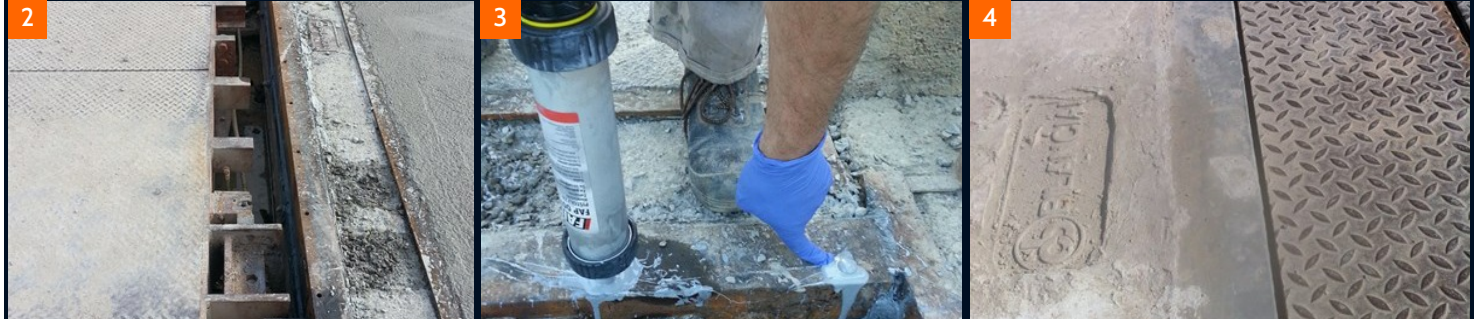
## PHOTOS

Concrete surface under the metal plate on the approach to the truck scale was badly damaged due to misalignment of mating faces. Truck scale must be in operation during the two shifts per day, six days per week operation of the quarry so fast repair procedure required.

1. Damaged concrete under the old metal plate 2. New metal plate in position with sealed edges. 3. Injection of Belzona 5811 4. Application completed

The application was carried out in accordance with Belzona Know-How System Leaflet GSS-9. After installation of the new metal plate, the edges of the mating faces were sealed with Belzona 1111 to prevent leaking of Belzona 5811 which was injected through previously drilled holes.
