# BELZONA PROTECTS VIBRATORY SCREENING MACHINE

ID: 6149

## PROBLEM

The bottom of the vibratory screen suffered damage from abrasion. Customer needed a fast repair in order to keep downtime to a minimum.

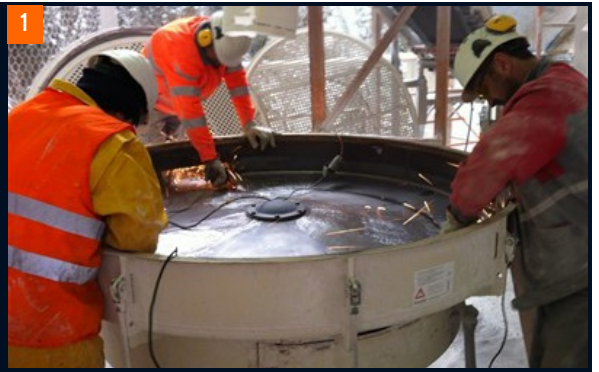
1. Surface preparation in progress 2. Surface prepared 3. Application completed

The application was carried out in accordance with Belzona Know-How System Leaflet SHM-13.

Belzona 1812 (Ceramic Carbide FP)
