# BELZONA PROTECTS NEW HOPPER FROM ABRASION

De-dusting machine operating in the cement plant.

Cement plant, Croatia

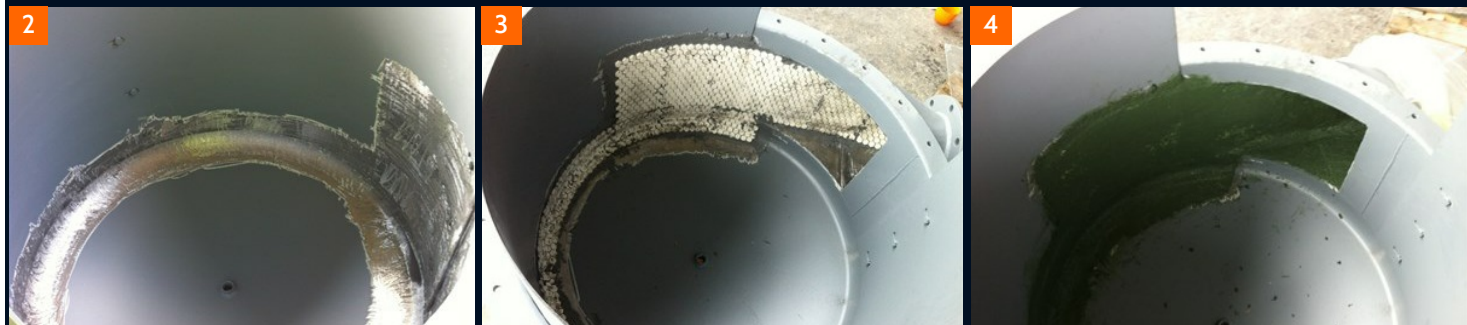
The hopper is situated on top of the machine and one section suffers from severe abrasion. Structural failures on that section would cause safety and operational problems.

1. Damaged old hopper. Welding to critical section is visible from the outside  
2. New hopper with surface prepared. 3. Belzona 9811 bonded in place using Belzona 1111 4. Grouting Belzona 9811 tiles with Belzona 1813.

Premature failure of the hopper caused downtime and hopper needed to be repaired by welding. In order to prevent such failures in the future and extend working life of the hopper, customer was looking for a way to protect its critical section before installation. Belzona is already used on this machine (pipe elbow that is connected to the hopper), so customer decided to also use Belzona in this case.
