# WATER STORAGE TANK UPGRADED WITH BELZONA COATING

ID: 6157

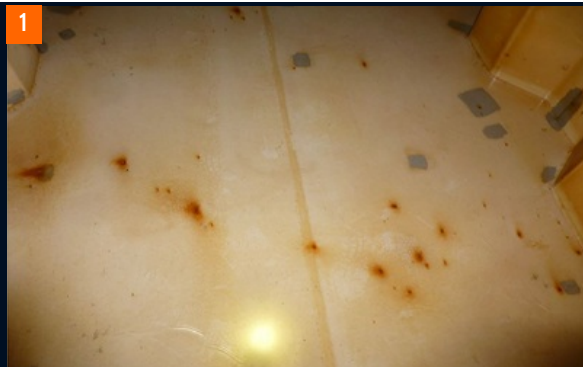
Tank was suffering localised pitting and coating breakdown on deck plates and beam edges. Superior erosion resistant coating required to protect the vessel from further corrosion.

1. Deck of tank showing areas affected by corrosion 2. Example of pitting on tank wall 3. Areas of corrosion and pitting repaired with Belzona 1111 4. View of completed application on water tank
