# BELZONA SEALS NEW PIPES IN HOTEL WATER RESERVOIR

ID: 6168

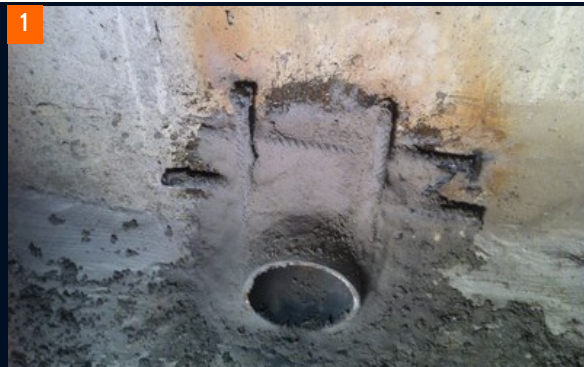
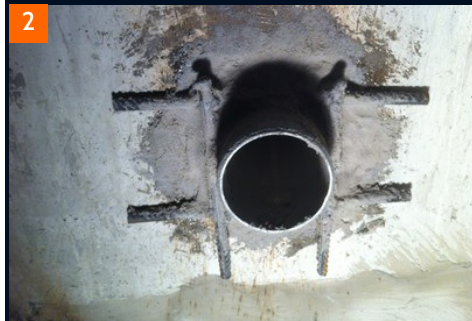
New pipes drilled into water reservoir needed to be anchored and sealed to the tank wall.

1 & 2. Internal application to secure new pipes

The customer was looking for reliable solution since on previous experience leaks had occurred around the pipes. Belzona 4111 provides high bond strength without shrinking enabling a secure leak free installation.

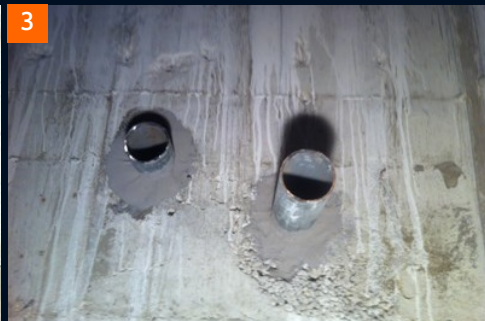
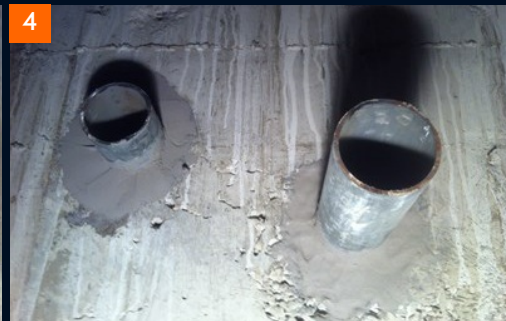
3 & 4 External fixing of pipes
