# BELZONA REPAIRS CORRODED HEAT EXCHANGER FLANGE

ID: 617

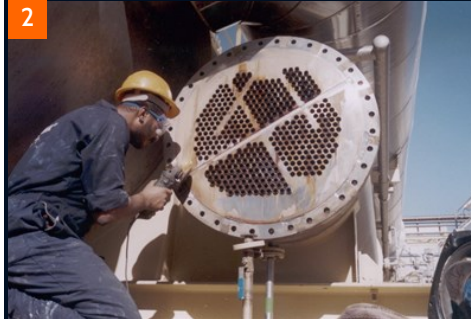
The flange of the heat exchanger was corroded preventing correct sealing.

1. General view of the flange
2. Surface preparation of the flange
3. Belzona 1311 applied to the corroded areas
4. Flange repaired and protected
