# ACCESS STEPS REFURBISHMENT WITH BELZONA

ID: 6177

Access steps and walkway at a prominent medical research facility

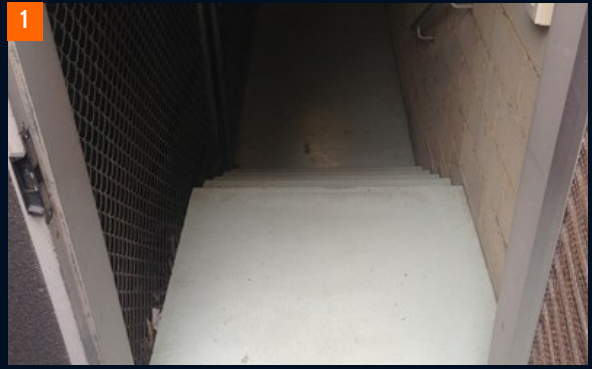
The access steps to the research facility had become worn over time making them prone to slip hazards, especially after periods of heavy rain which had been highlighted by a recent HSE audit.

1. Existing flooring 2. Existing flooring, alternate view 3. Finished application 4. Close up showing additional aggregate

Application was carried out in accordance with Belzona System Leaflet FPA-8. The existing sound coating was thoroughly abraded before applying the Belzona 5231 system. Additional aggregate was added between coats to provide a higher level of slip resistance.
