# DEIONIZER COATED WITH BELZONA

ID: 618

Deionizer in the company's water treatment plant.

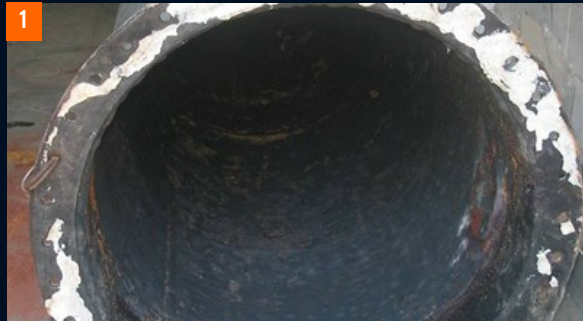
1. General view of the deionizer
2. The failed rubber lining
3. Deionizer from inside after coating
4. Application completed

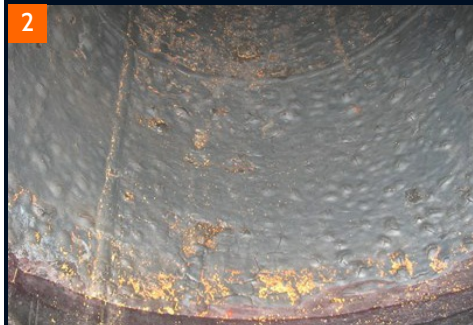
Failure of rubber lining due to aging and chemical attack.

Rubber lining was removed then Belzona® 5811 was applied to provide long term protection to the deionizer. The deionizer was inspected after a year and found to be in perfect condition. More deionizers were then coated.
