# BELZONA UPGRADES ACID BUND

ID: 6183

Damaged Sulphuric acid bund at power station

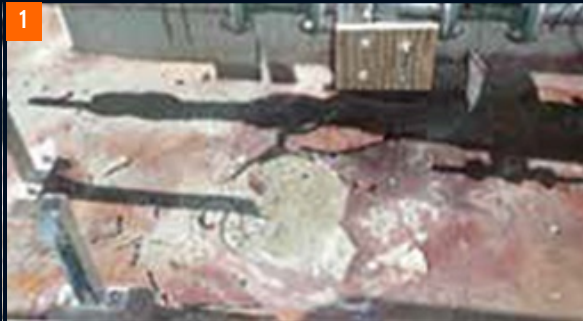
Spills of sulphuric acid over many years had significantly damaged the containment capabilities of the bund leaving it questionable about whether it could contain a major spill.

1. The badly damaged bund area 2. The bund re-profiled using Belzona 4111 3. The first coat of Belzona 4311 applied 4. The completed application

Application was carried out in accordance with Belzona System Leaflets TCC-9 and TCC-15. After removing damaged sections of old coating, the underlying concrete was neutralised using HP water and bicarbonate of soda. After drying damaged areas of concrete were rebuilt with belzona 4111 before coating overall with Belzona 4311 system.
