# CAUSTIC BUND REFURBISHED WITH BELZONA

ID: 6184

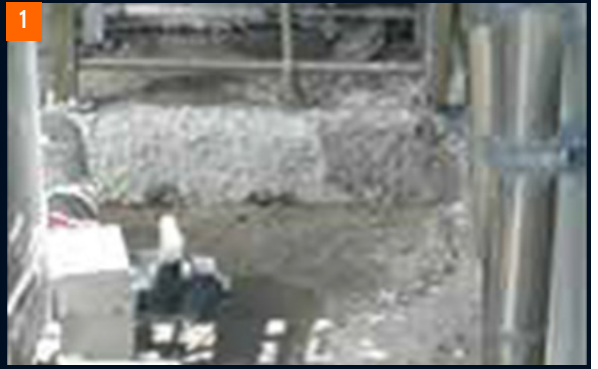
Spills of Caustic soda over many years had caused serious deterioration of the concrete floor and support plinths under the valves.

Badly damaged concrete and support plinths in a Caustic Containment area.

1. The damaged bund 2. Floor rebuilt and profiled with B4111 3. 1st coat of Belzona 5811 applied 4. 2nd coat of Belzona 5811 applied to complete the application

Application was carried out in accordance with Belzona System Leaflets TCC-9 and TCC-15. After removing damaged concrete the area was high pressure water washed and neutralised with dilute hydrochloric acid. When dry, damaged areas of concrete were rebuilt with Belzona 4111 before coating with Belzona 5811 to provide overall protection.
