# BELZONA ELIMINATES TRIP HAZARD FROM DRAIN COVERS

ID: 6185

Shopping centre, Bankstown, Australia

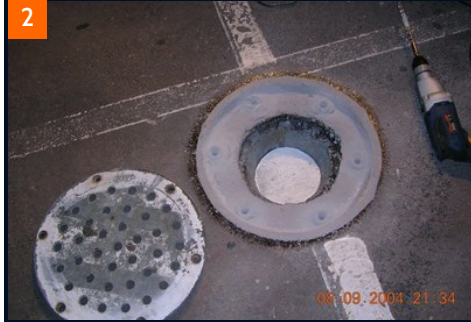
Existing drain covers were proud of surface creating a potential trip hazard.

1. The raised drain plate
2. Belzona 4111 to rebuild drain
3. The plate fixed in place
4. Coated with Belzona 4411

Application was carried out in accordance with Belzona Know-How System leaflets FPA-1 & FPA-8. Concrete was ground away and Belzona 4111 used to re-install plates at ground level. Plates were then coated with Belzona 4411 Granogrip to provide slip resistance.
