# BELZONA WATERPROOFS CORPORATE HEADQUARTERS

ID: 6188

## PROBLEM

Improper sealing of the roof structure of the high rise building was allowing water to leak into the offices below.

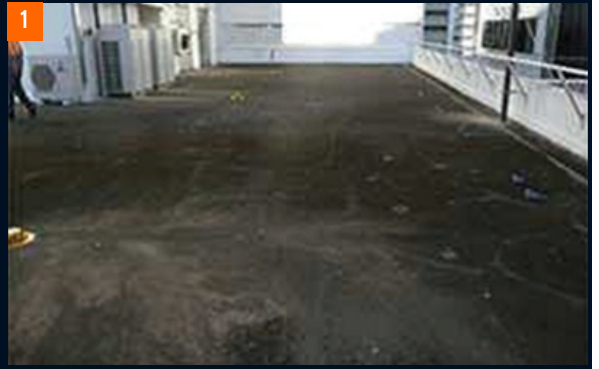
1. The existing roof 2. Power washing in progress 3. Cracks exposed and sealed with Belzona 4151 4. The finished application after application of the Belzona 3111 system
