# DAMAGED RUBBER LINING RESTORED

ID: 619

Water media filter

Water treatment plant, Egypt

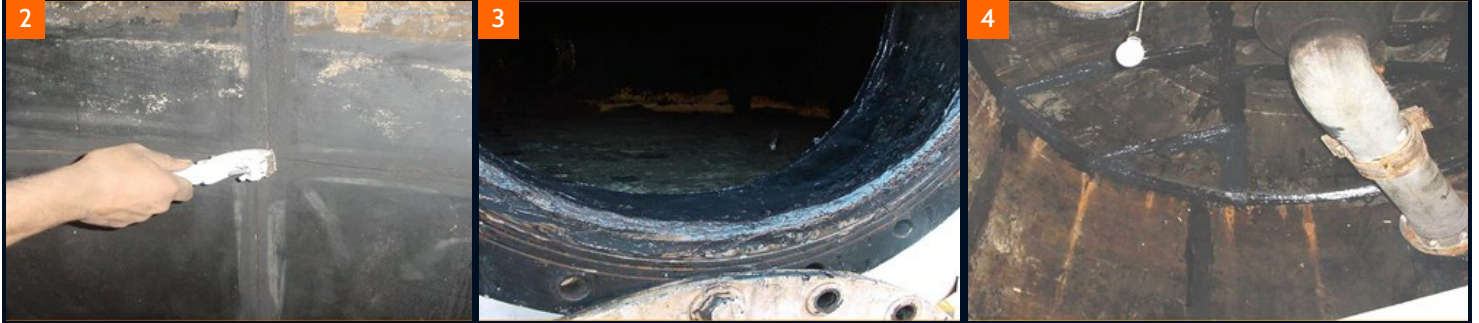
## PHOTOS

Peeled-off lining at welding edges causing under lining corrosion due to sea water penetration between the rubber sheets.

1. Peeled-off lining
2. Surface preparation of rubber at the welded seams areas
3. Problem solved
4. Sealed seams

Application was carried out in accordance with Belzona Know-How System Leaflet TCC-3.

Belzona performed easy, onsite repair of the existing lining. No new lining is required and all seams between the rubber sheets were well sealed and protected.
