# BELZONA KEEPS TENANTS DRY AND HAPPY

ID: 6197

High Rise Office complex in the Brisbane Central Business District.

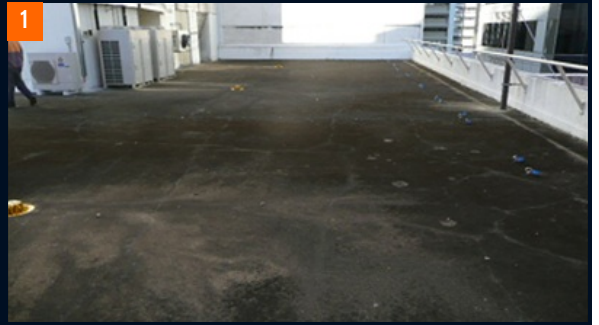
Cracks in the flat roof were allowing water to penetrate into the offices below.

1. Original roof condition  
2. Cracks in roof  
3. Defects in the roof that needed repair  
4. The finished application after application of the Belzona 3111 system
