# BELZONA SQUARES THE CORNER

ID: 6198

Damaged wall at a local shopping centre

Shopping centre, Brisbane, Australia

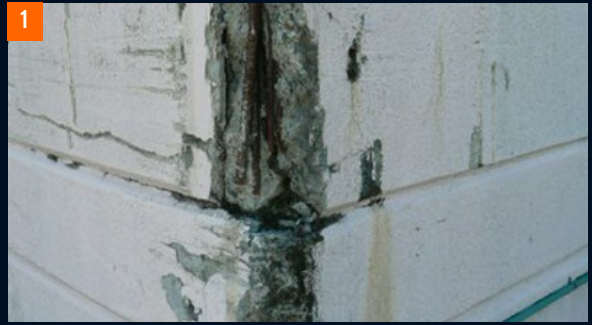
A delivery truck had reversed into the wall of the shopping centre, damaging the wall and exposing the reinforcement.

1. Close up of the original damage 2. Crack stabilisation complete 3. Rebuild of the damage underway 4. The completed application

Application was carried out in accordance with Belzona System leaflet WPA-4. All loose material was removed and the exposed reinforcement bars cleaned to remove all rust. The remaining cracks in the wall were stabilised and then injected with the Belzona 4151. Once the Belzona 4151 had cured, the cracks were vee'd out and filled using the Belzona 4111. The damaged areas were also rebuilt using the Belzona 4111 to restore the original profile.
