# BELZONA EXPANSION JOINT SEALANT FOR CORPORATE OFFICE

ID: 62

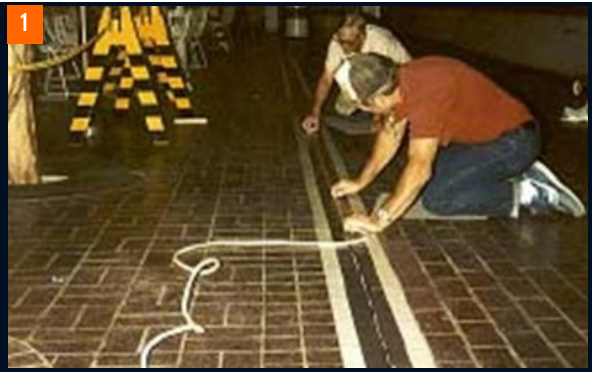
Existing sealant breaking loose, creating a pedestrian safety hazard.

1. The application was carried out with the in-house maintenance staff of the power company. Closed cell foam backer rod being inserted.
2. Applying Belzona 2221.
3. Expansion joint sealed.

The application was carried out in accordance with Belzona Know-How Leaflet FPA-6.

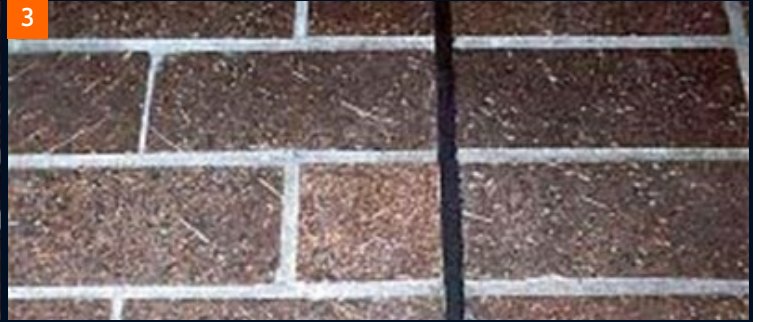
All expansion joints were sealed with approximately \$30,000 in Belzona product. Nearly ten years after, they are still in good shape.
