# BELZONA REPAIRS CAR PARK FLOOR

ID: 6200

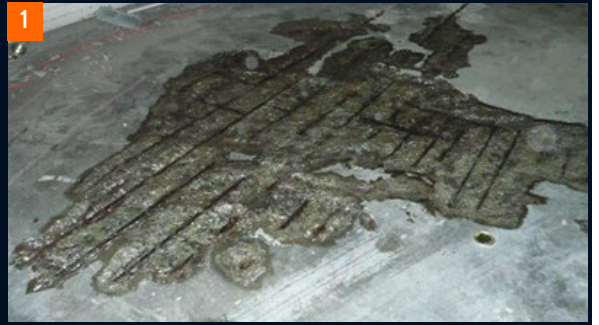
A poorly constructed concrete slab floor had been worn away exposing the reinforcement bars that were becoming a trip hazard

1. The damaged floor showing exposed re-bars
2. More damaged areas
3. Rebuilding with Belzona 4111 in progress
4. Completed application

Application was carried out in accordance with Belzona System Leaflet FPA-1. The damaged concrete was removed and the re-bars prepared using wire brushing to remove corrosion from the surface. Once cleaned and vacuumed, the Belzona 4111 system was then applied to the damaged areas and feathered out to provide a smooth surface. Once an area had been completed and cured sufficiently, it was opened up to the public and the process repeated at the next location.
