# KERBS FIXED IN PLACE WITH BELZONA

ID: 6203

Shopping Centre car Park

Shopping centre, Brisbane, Queensland, Australia

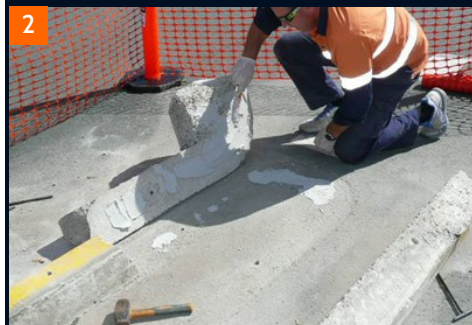
Delivery of some shipping containers carrying tools and equipment for the refurbishment of the centre had caused damage to the demarcation kerbs around the car park.

1. The damaged/missing kerbs 2. Belzona 4111 applied to underside of kerb 3. Belzona 4111 applied to floor prior to refitting the kerb 4. Kerbs permanently back in position

Application was carried out in accordance with Belzona System Leaflet FPA-11. The damaged sections of kerb were removed to allow the substrate to be cleaned and prepared before bonding the original kerbs back into place using the Belzona 4111 system.
