# NEW KERB CREATED WITH BELZONA

ID: 6204

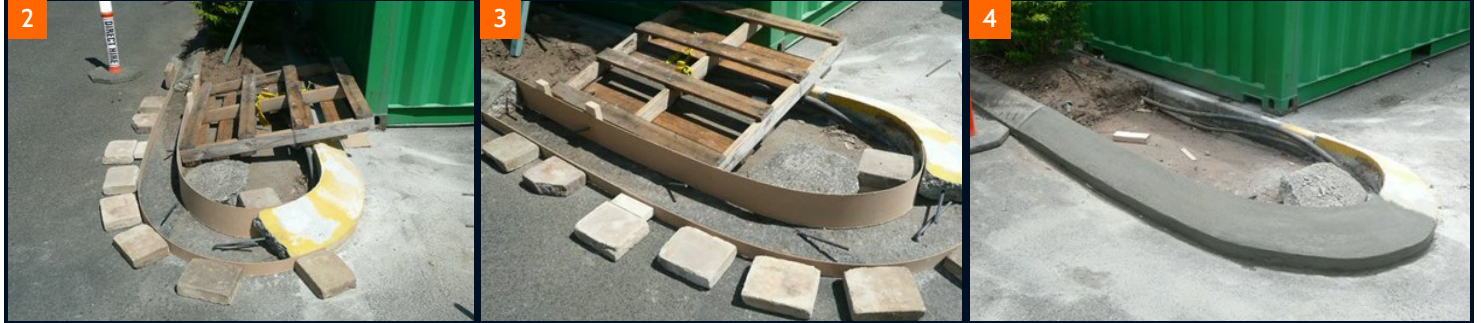
## PHOTOS

The existing kerb had been damaged and needed to be repaired / replaced

1. The damaged missing nosings 2. Former being constructed 3. The former in position ready for repair to take place 4. The finished application, after removal of former, ready for painting

Application was carried out in accordance with a modified version of Belzona System Leaflet FPA-1. After removing damaged kerb an MDF former was installed and Belzona 4111 applied into the former to re-create the original kerb profile. Once Belzona 4111 had sufficiently cured, the former was removed leaving the perfectly formed kerb.
